December 11, 2023

This report summarizes the results of our structural assessment for a multi story property at 3400 Fannin St, Houston, TX 77004, USA. We are not able to identify the occupancy type of the building during the inspection.

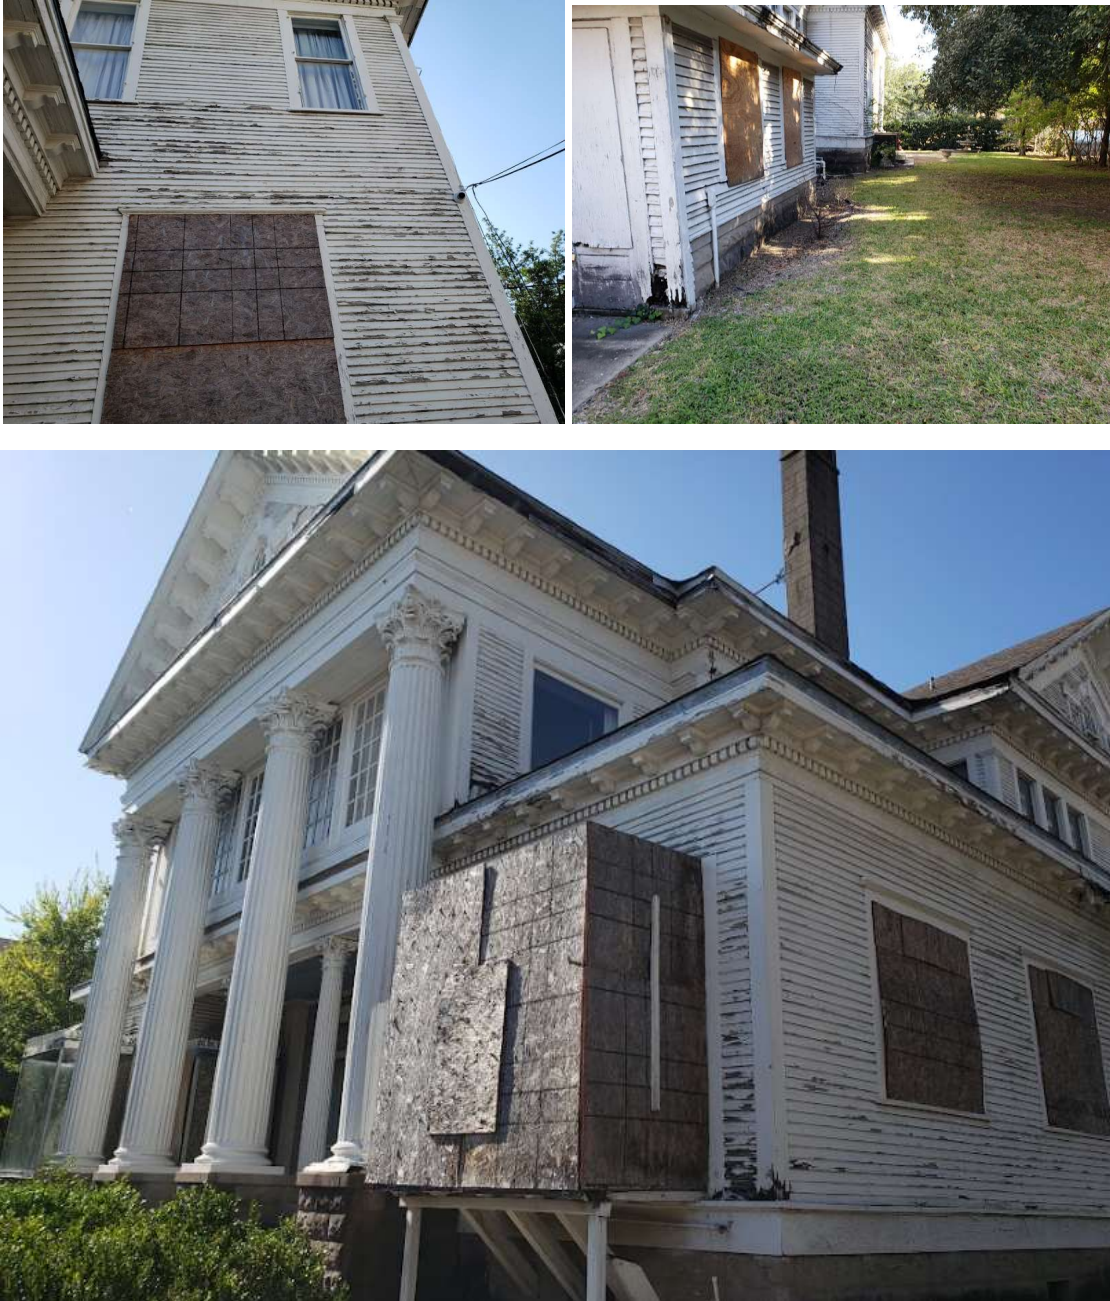
- There are several broken windows covered by Plywood which it increases the risk of water intrusion to the building (figure 2)
- There are instances of visible rotted fascia plate, soffit, and probably rafters/joists

Figure 2 - Broken Windows; increased potential for water intrusion and respectively higher chance of framing rot

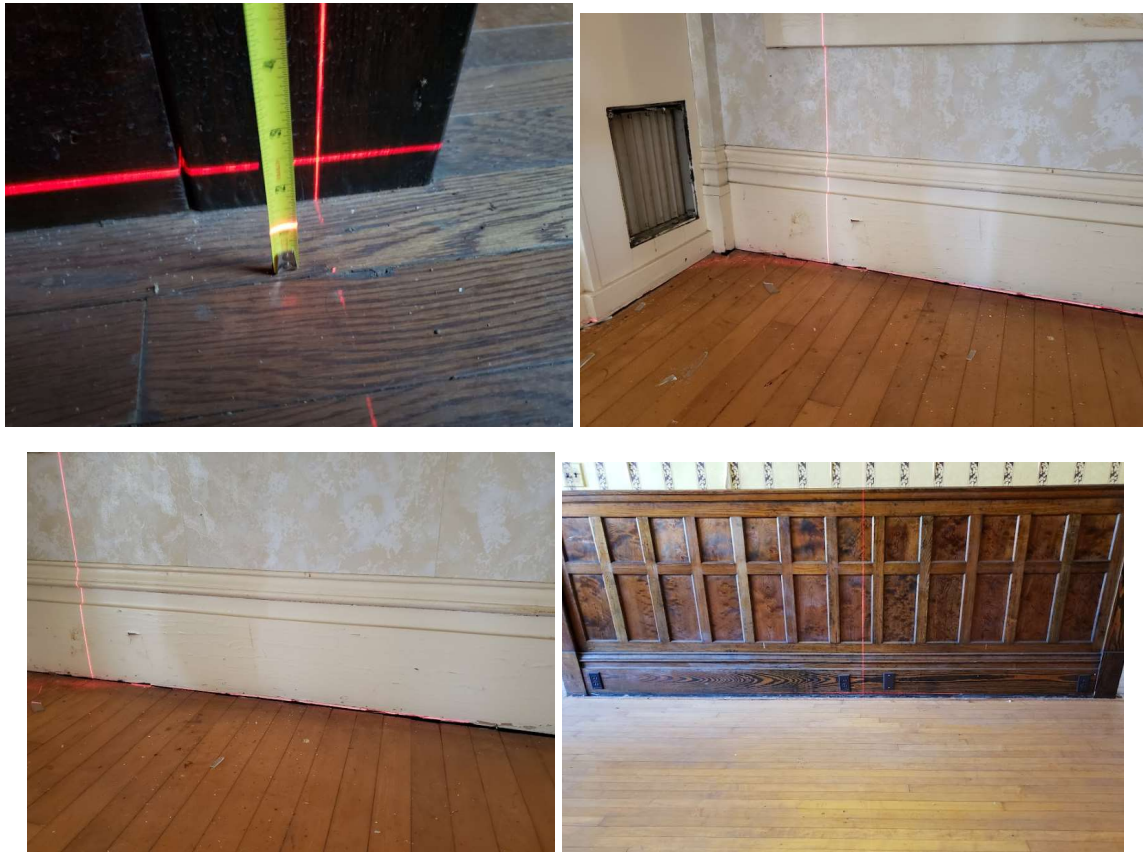
- The maximum top of floor level elevation difference measured at this building is about **1” over 15’ 0”**. This level of differential deflection is above acceptable tolerance which is L/240 (figure 3)
- There are multiple signs of water intrusion to the inside of the building resulting from broken windows and/or failed roofing. The extent of the damage in some areas has cause partial failure of the dry walls (figure 9 & 8)
- Instances of gap between the bottom of the wall and flooring can be observed. This may be indicating foundation issues or failure of framing or both (Figure 6)

figure 3- There are instances of top floor elevation differential settlement exceeding $L/240$ which is beyond acceptable limits.

- 1) Remove all interior and exterior sheathing and inspect the framing, replace all rotted and soft wood members under supervision of a professional engineer
- 2) Restore building envelope at the direction of a licensed engineer or qualified architect
- 3) Repair foundation under supervision of a licensed engineer

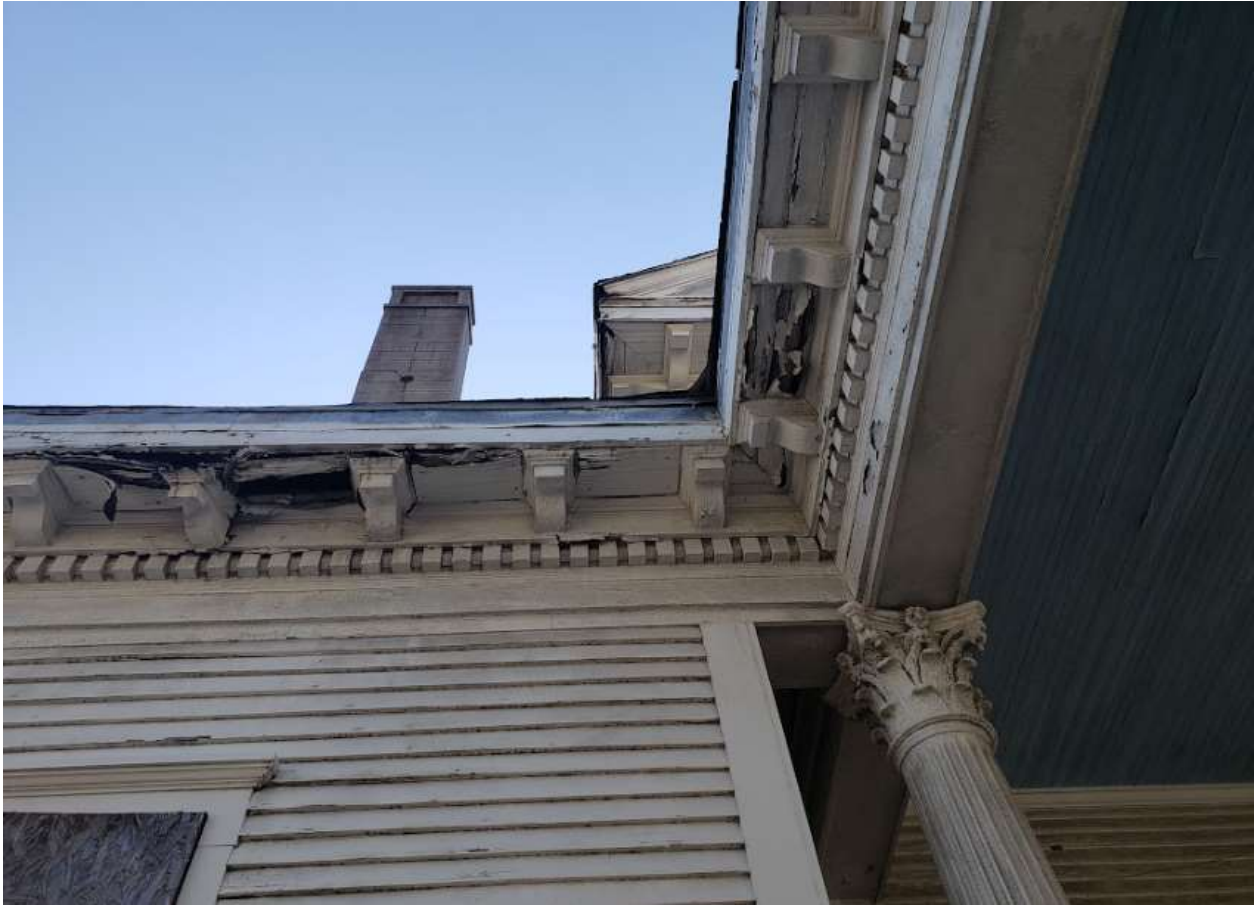
Figure 4- Fascia plate and soffit are visibly rotten, the joists/rafters may be damaged as well due to weather exposure

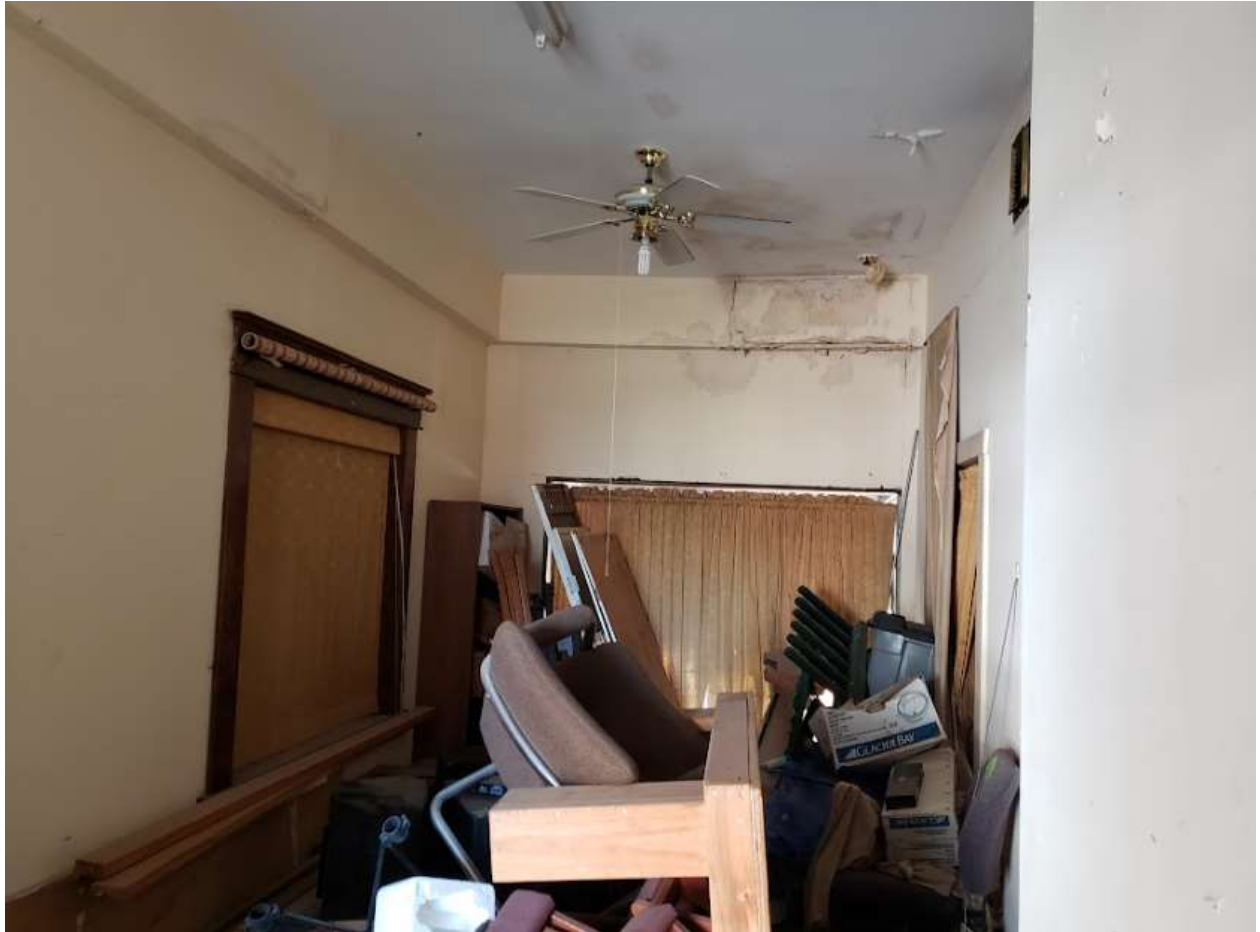
Figure 5- Visible signs of water leak, Water leak impose high risk to longevity of structural framing and building envelope

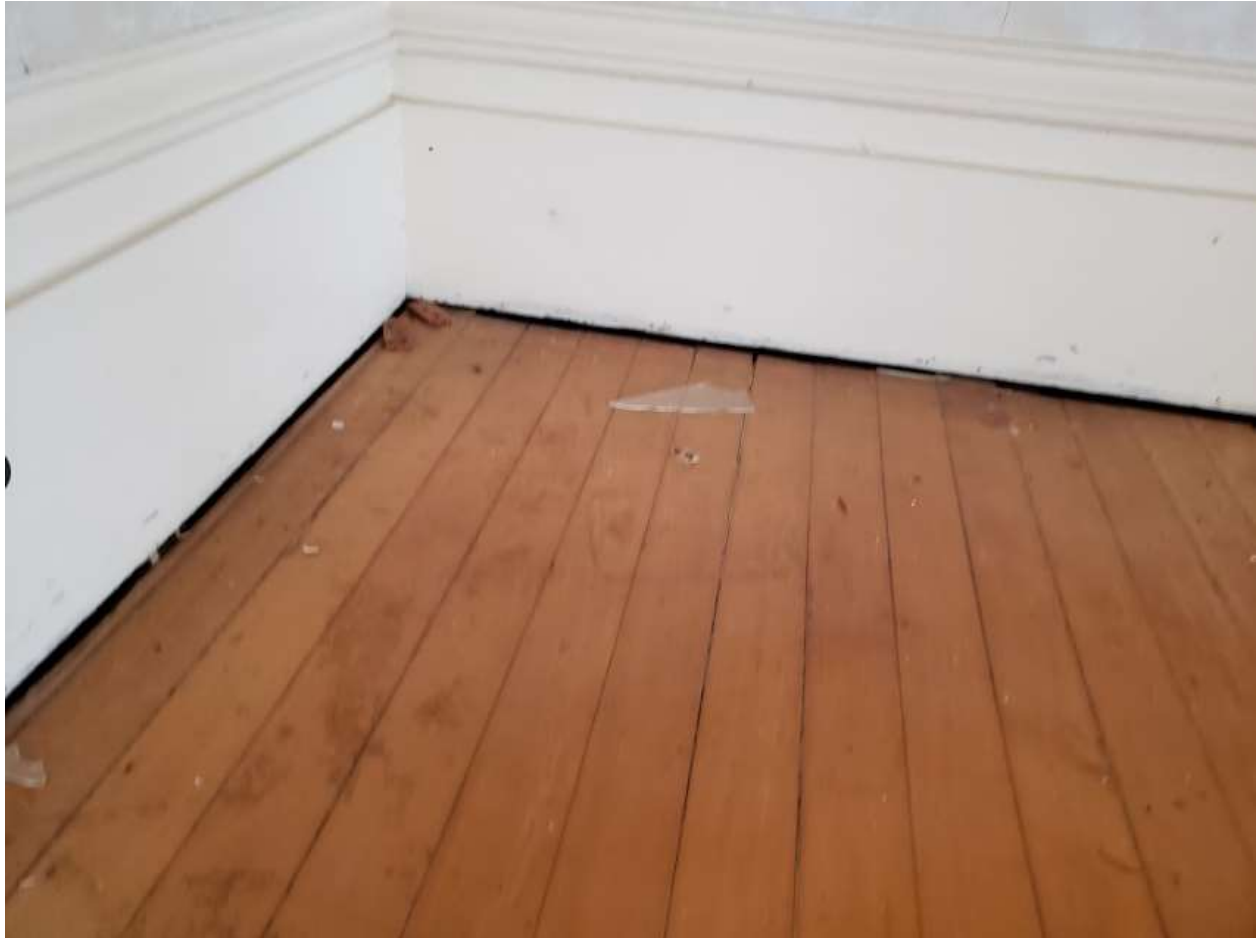
Figure 6- Gap between bottom of wall and flooring, this may indicate foundation issues (settlements).

Framing may also be compromised

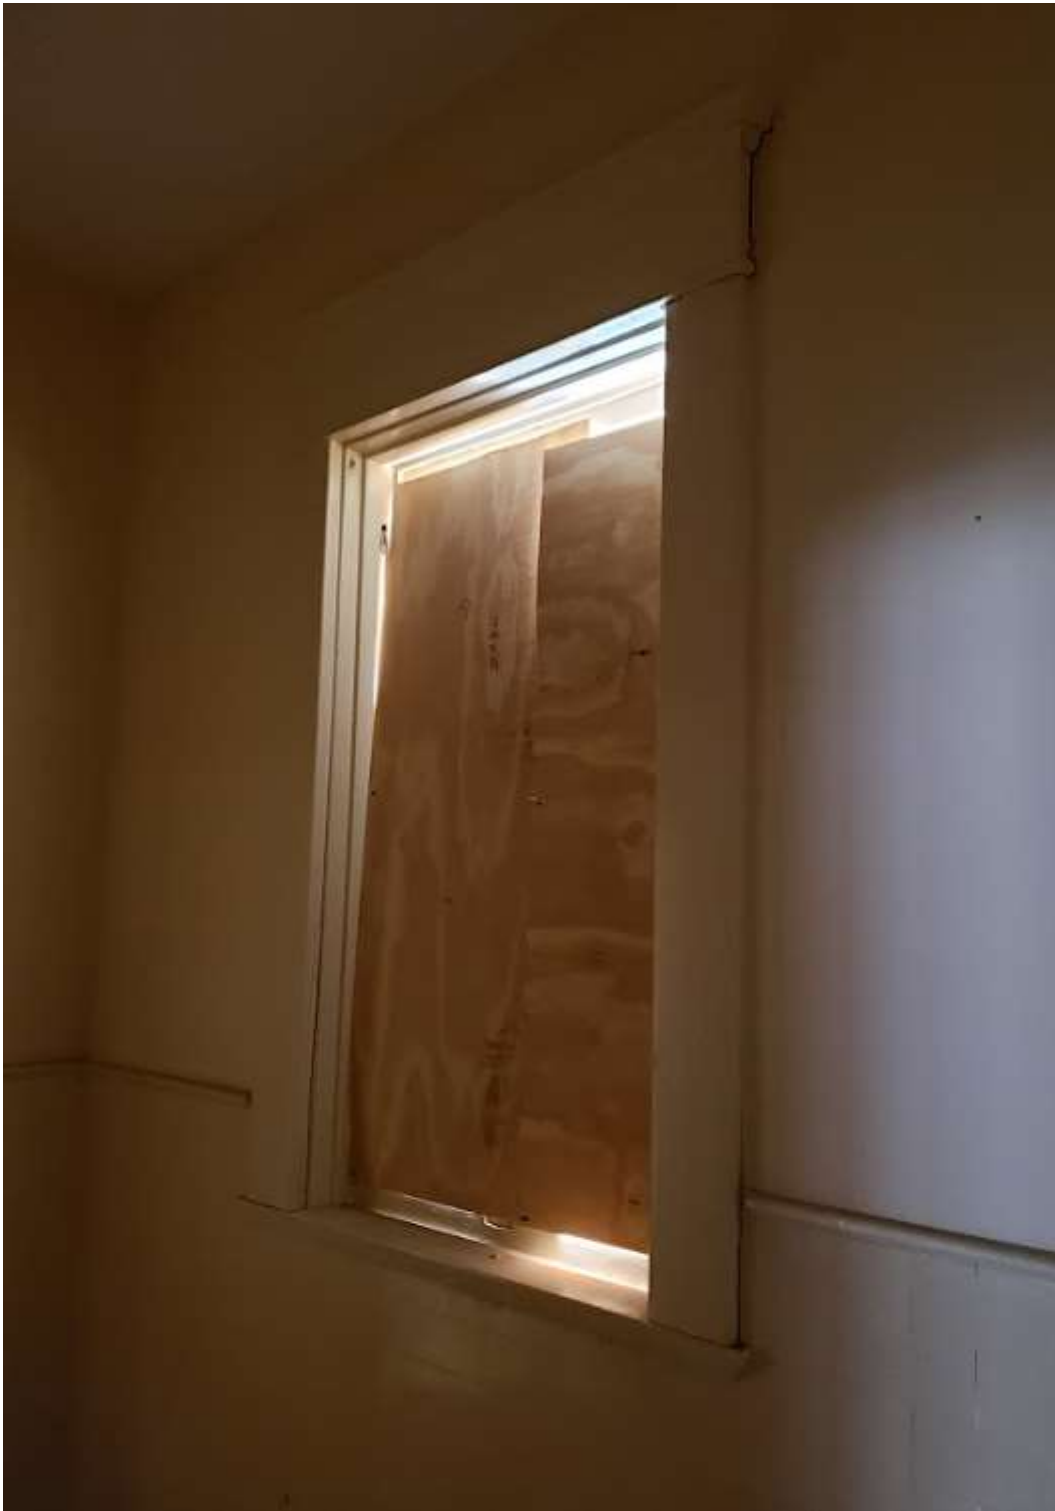
Figure 7- Gaps around window openings may indicate framing issues

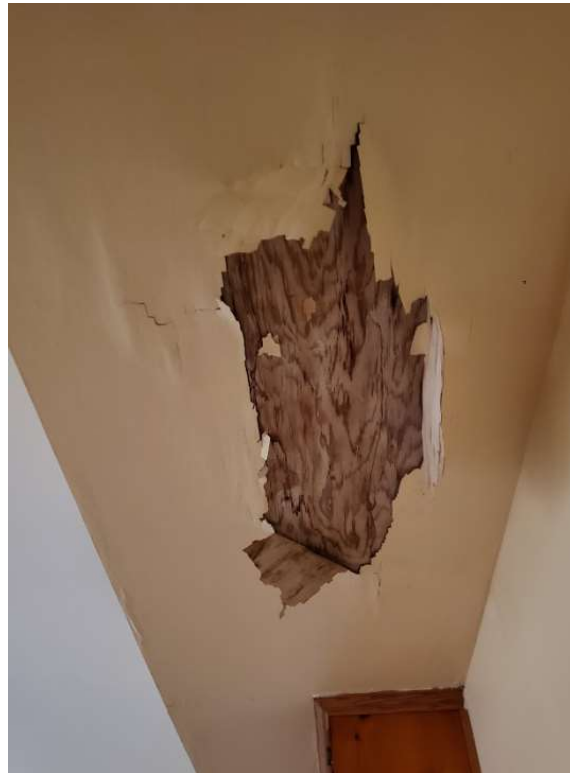
Figure 8 - Visible Water Damage. It is expected the sheathing and framing to be exposed to water which could result damage to structural integrity

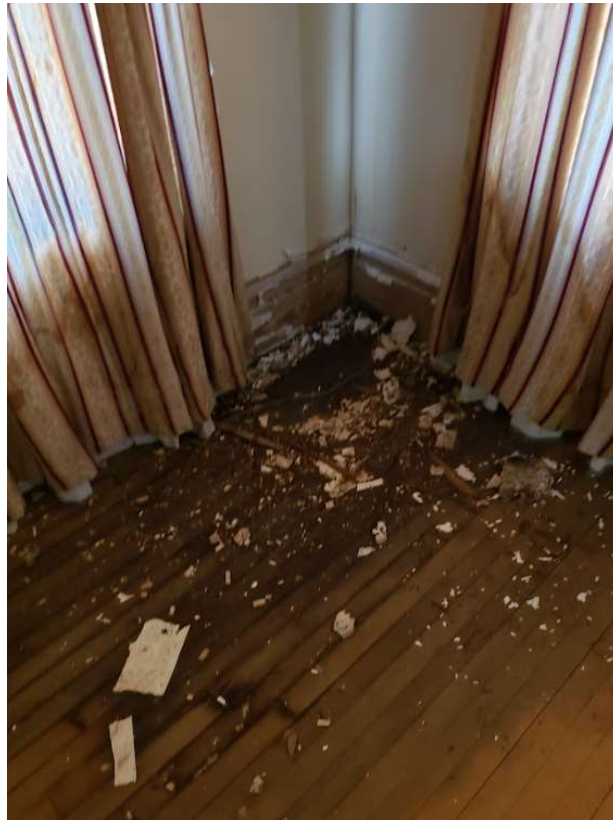
Figure 9 - Dry Wall Spalling due to water leak

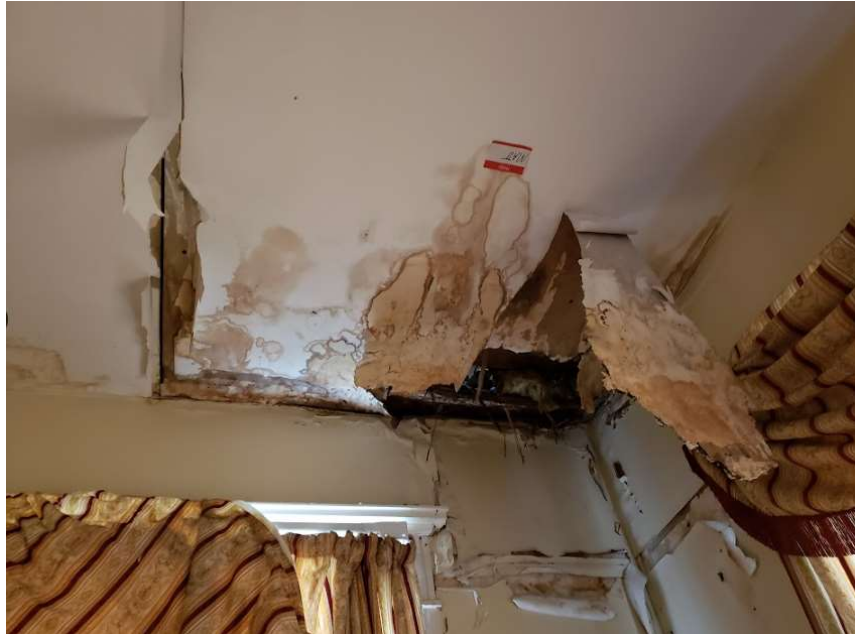
Figure 10- Failure of sheathing and framing most likely because of water intrusion. The framing is expected to be damaged severely at these areas

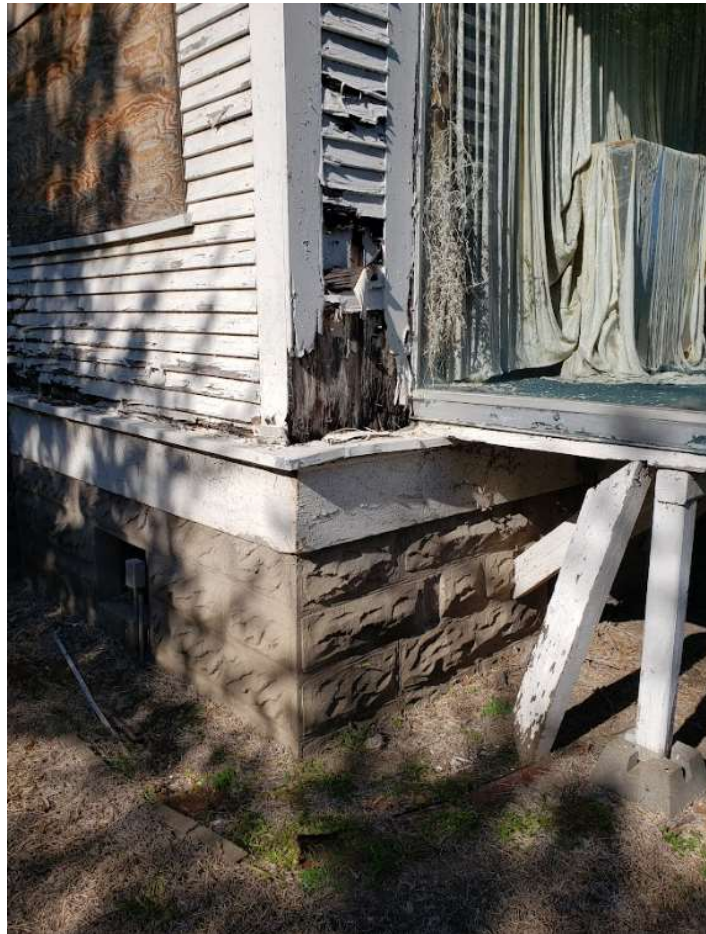
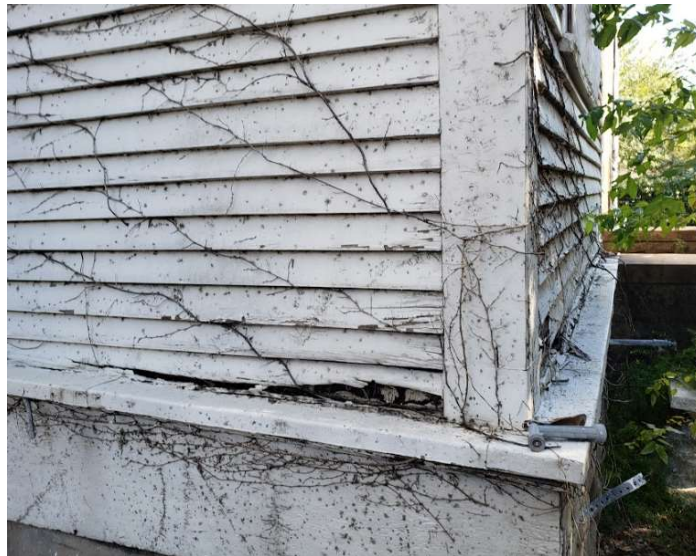
Figure 11- Visible partially rotted siding and failed building envelope

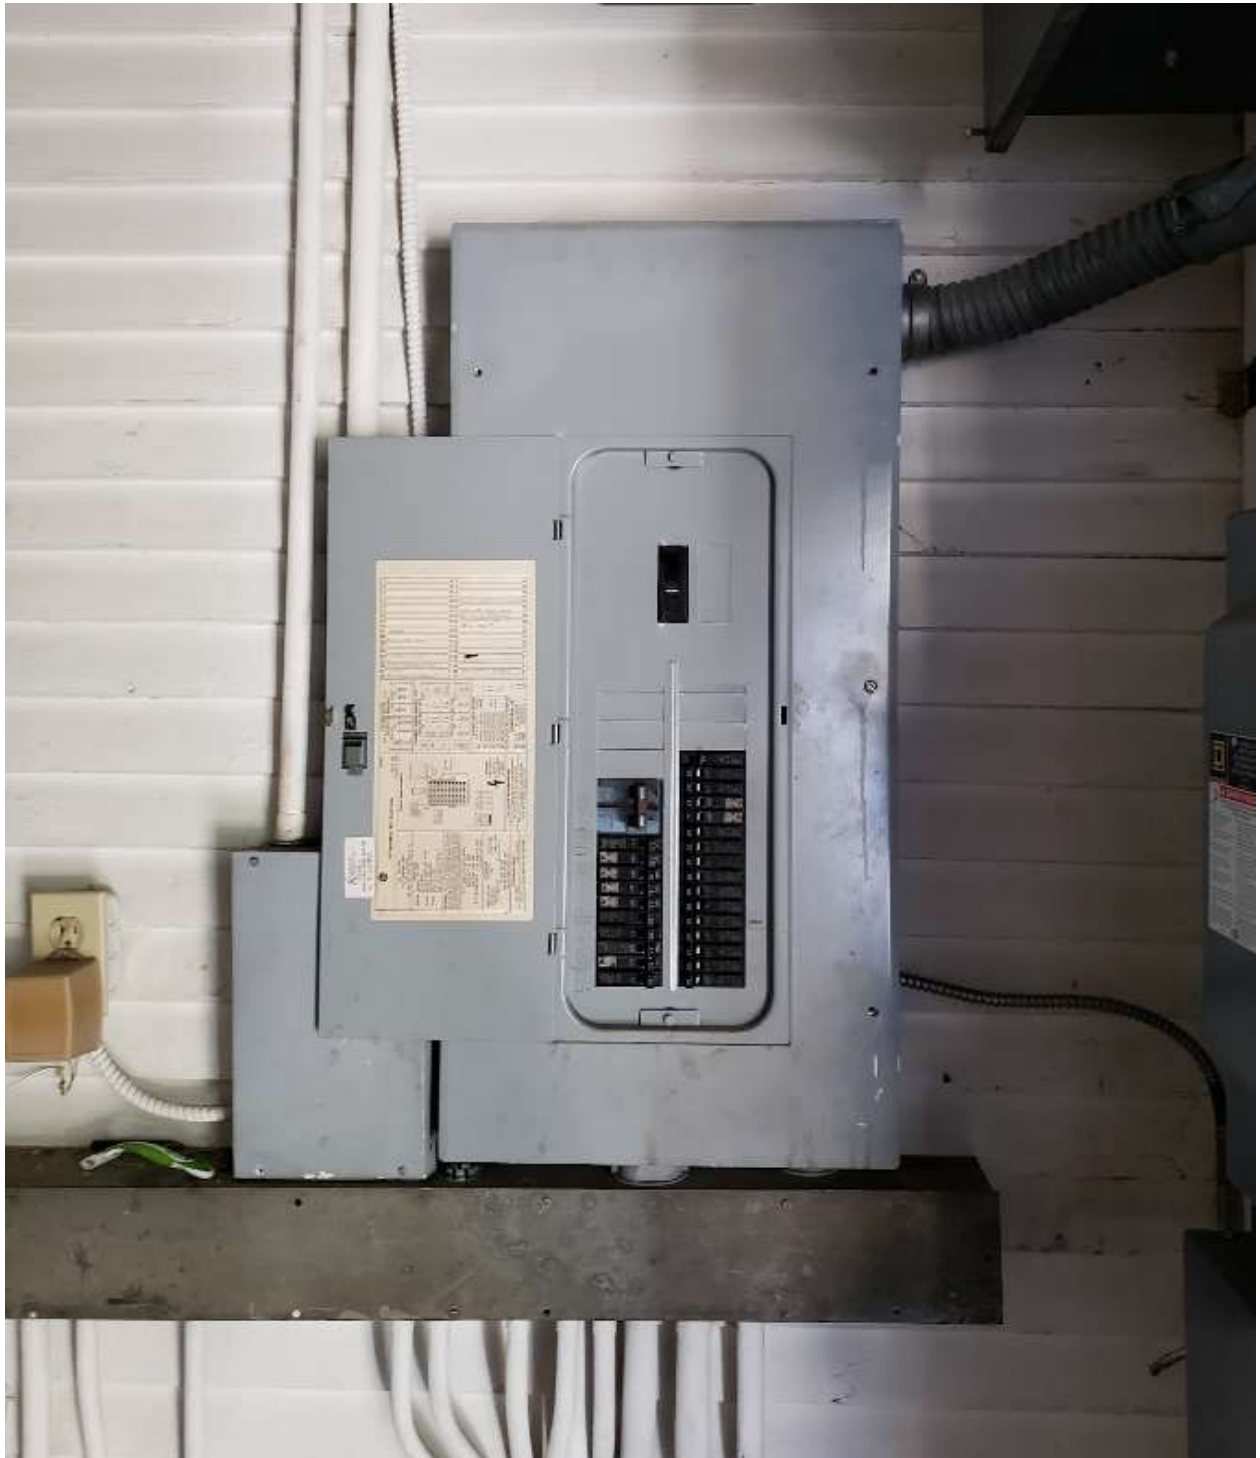
Figure 12- Electrical panel has passed its useful life and some parts are missing

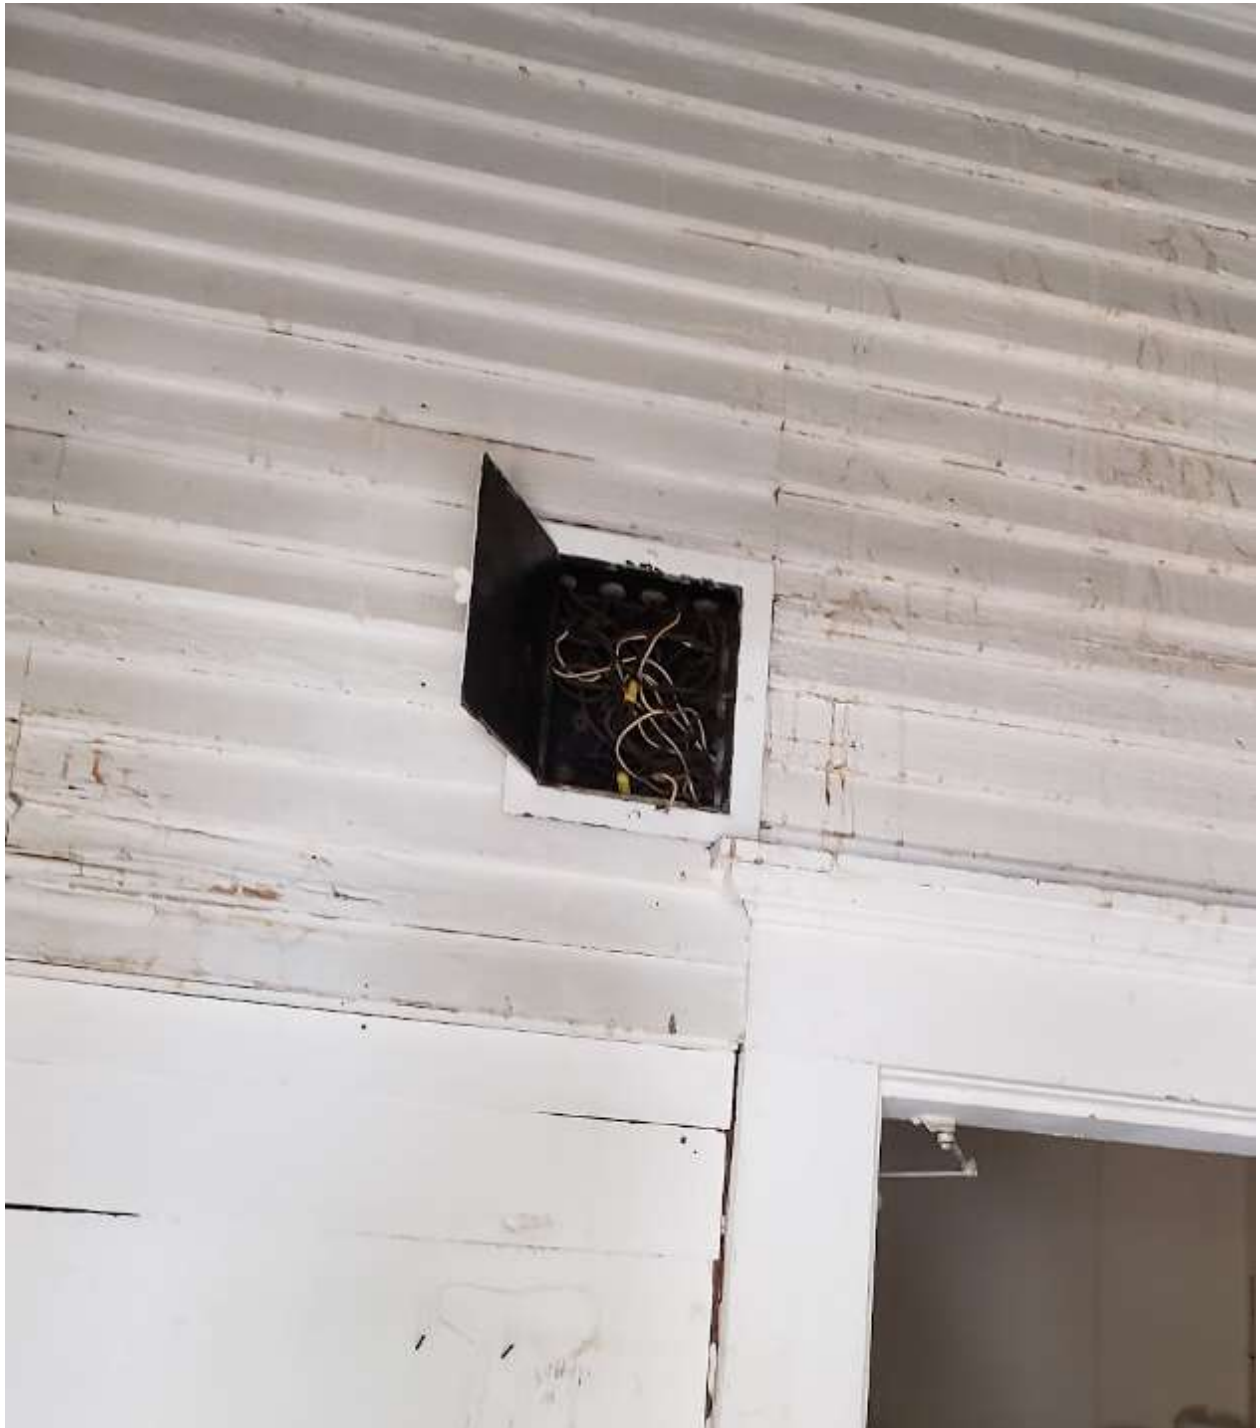
Figure 13- Exposed electrical wiring imposes safety concerns

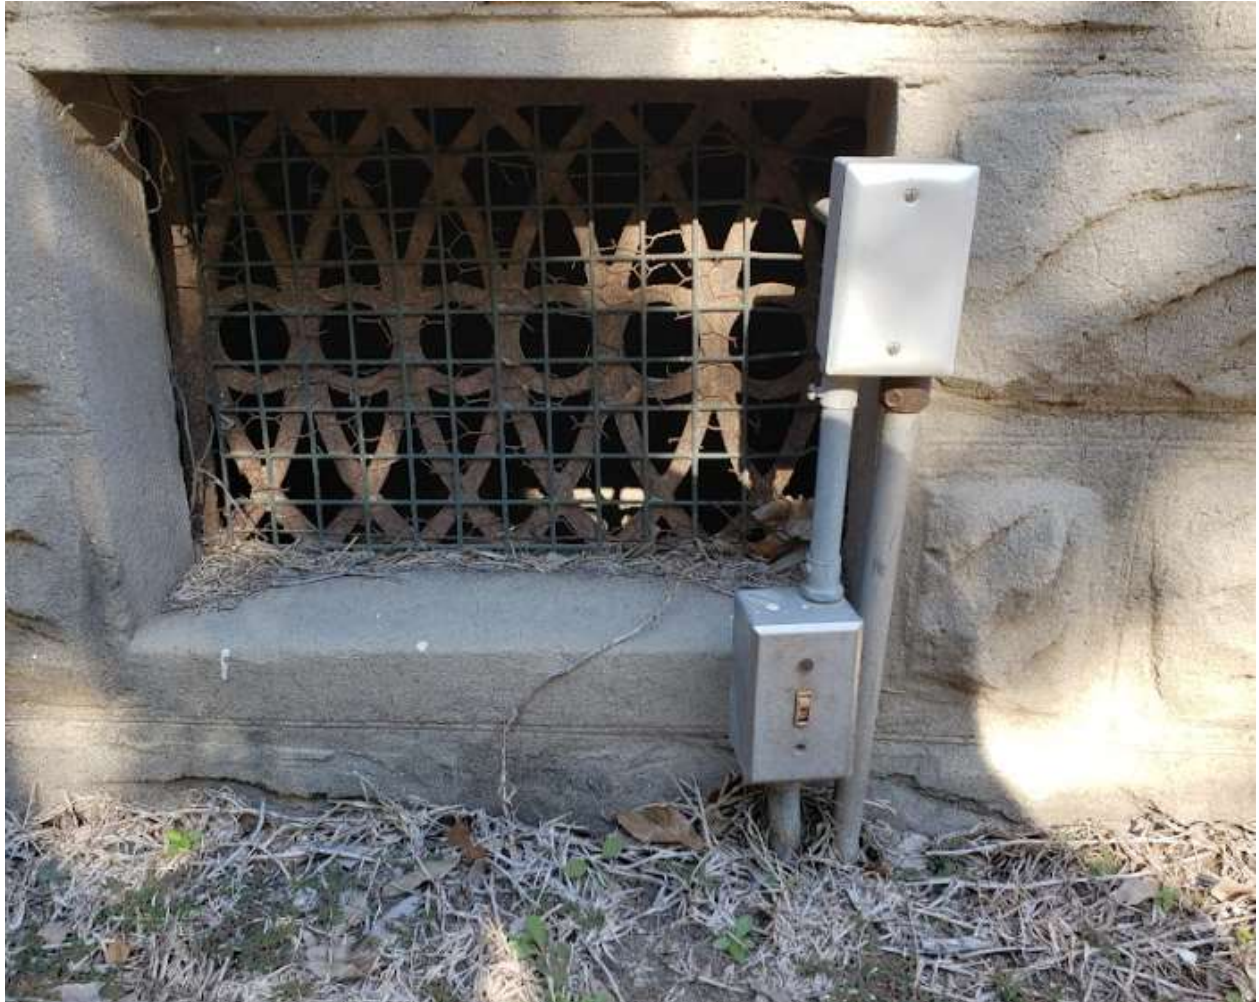
Figure 14- Electrical box found to be too close to ground which is not in conformance with the code
